Corrosion Risk Assessment

for Fire Sprinkler Systems

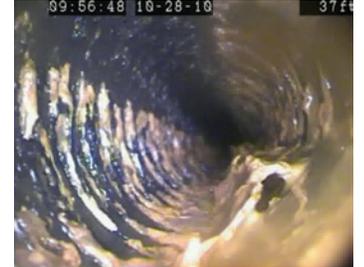
Branch line at 16ft with no corrosion, water filled with no air-water interface

Same branch line at 37ft with significant corrosion deposits, clear air-water interface

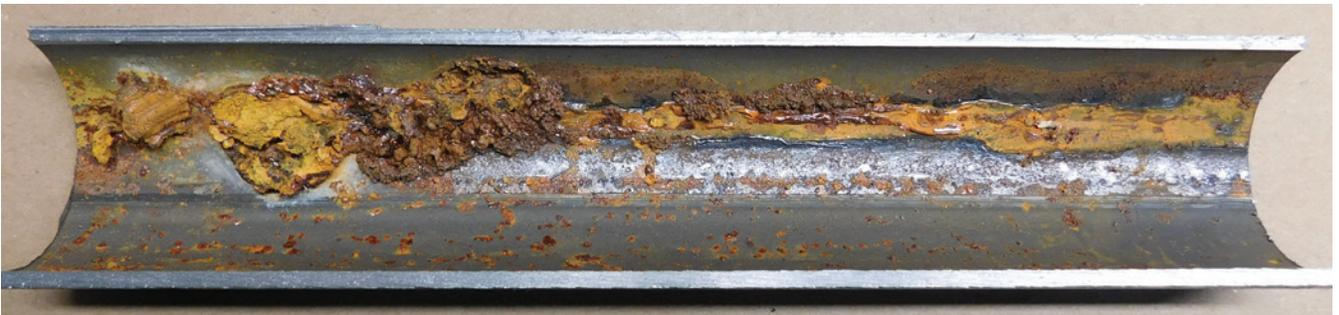
Before
Media
Blasting

- 1 Root cause of corrosion
- 2 Existing wall loss
- 3 Remaining service life

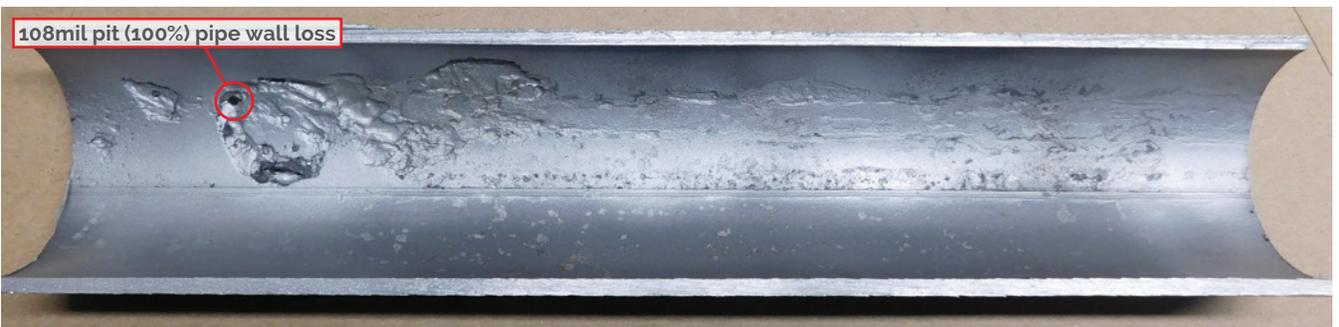
After
Media
Blasting

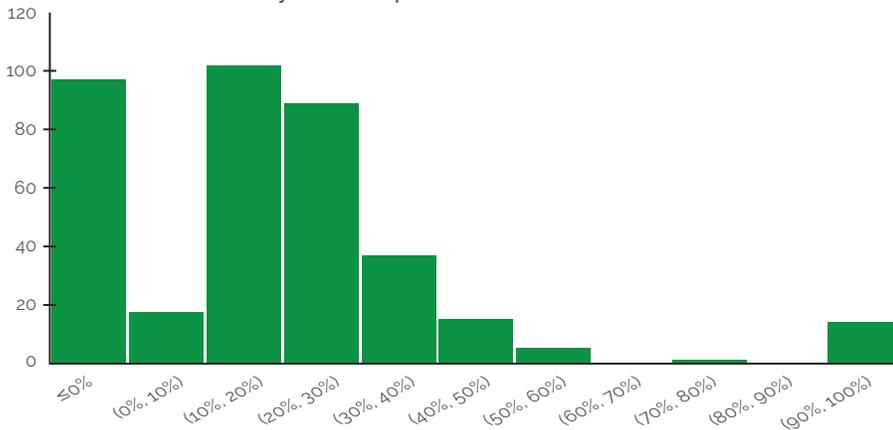
Wet System Replacement % Distribution

The goal of this assessment program was to eliminate leak risk while minimizing pipe replacement. Because corrosion was highly localized, on average only 22% of the pipe in each system was recommended for replacement.

“Compared to total system replacement, the reduction in pipe replacement saved the client 75%.”

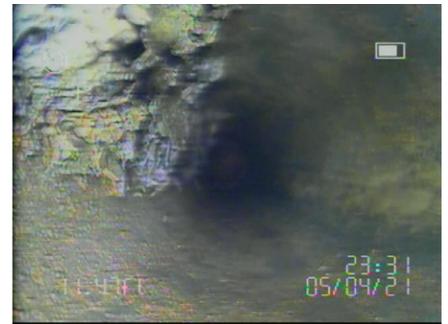
Location 4: 3" Low Main, Over Northern Wings

Significant issues were observed in the dry system piping:

- Trapped water throughout the dry system mains. This piping was run with little to no pitch
- Use of thin-wall schedule 7 pipe has significantly reduced service life of the system piping, with existing leaks found throughout the attic
- Large amounts of iron oxide deposits present throughout the main piping
- Several locations were observed to be 75%-100% obstructed by deposits
- These obstructive deposits would prevent the system from operating as designed in the event of a fire

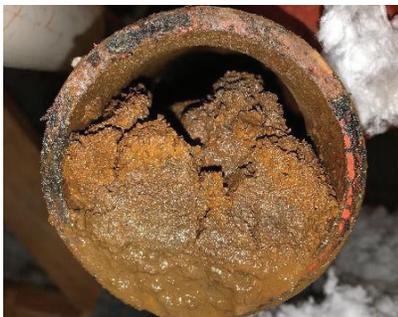
Location 8: 3" Low Main, End Cap over NW Wing
